Carvin Cove Dam (~~Inventory Number~~ VA 02301). Roanoke River Basin.
Botetourt County, Virginia. Phase I Inspection Report.

REPORT DOCUMENTATION PAGE		READ INSTRUCTIONS BEFORE COMPLETING FORM
1. REPORT NUMBER VA 02301	2. GOVT ACCESSION NO.	3. RECIPIENT'S CATALOG NUMBER
4. TITLE (and Subtitle) Phase I Inspection Report National Dam Safety Program Carvin Cove Dam Botetourt County		5. TYPE OF REPORT & PERIOD COVERED Final

REVISION NO. 1 TO PHASE I INSPECTION REPORT
NATIONAL DAM SAFETY PROGRAM

CARVIN COVE

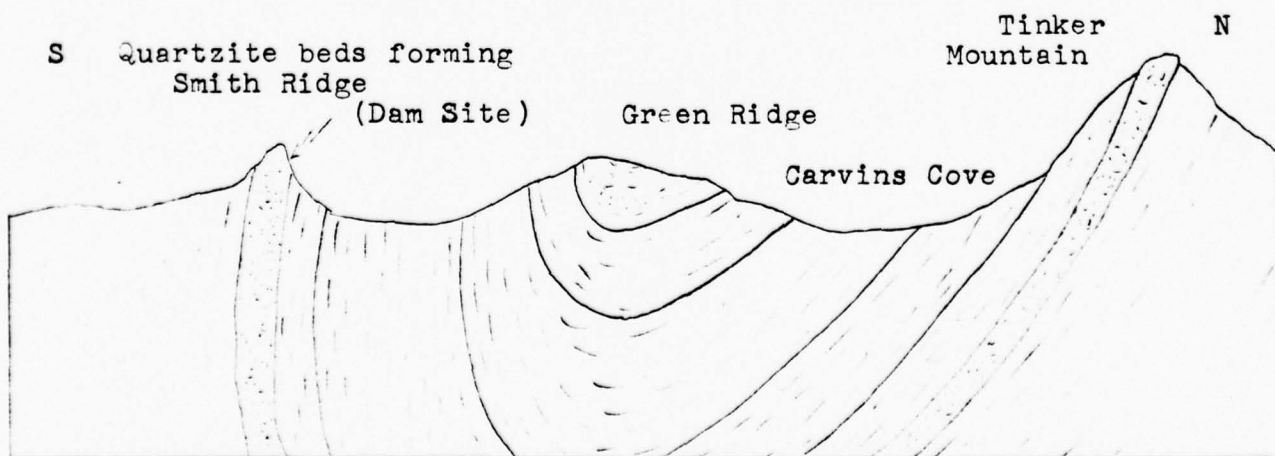
Figure 1. A generalized cross-section illustrating the ridge development and general structure at Carvins Cove. (Berkey 1924)

There is no record of any special foundation treatment being performed at the dam site. There were provisions in the contract documents for grouting under the dam if necessary, however, there are no records of any actual grouting being done. The need for such treatment does not seem to exist. The predominant joints in the dam site trend N55°-60°E (parallel to the dam) and dip 85°SE to vertical. These can be considered bedding joints. Several other joint trends are present but only one is significant. These joints trend N45°-50°W and dip 79°NE. They are, however, tight with no indication of enlargement or clay filling.

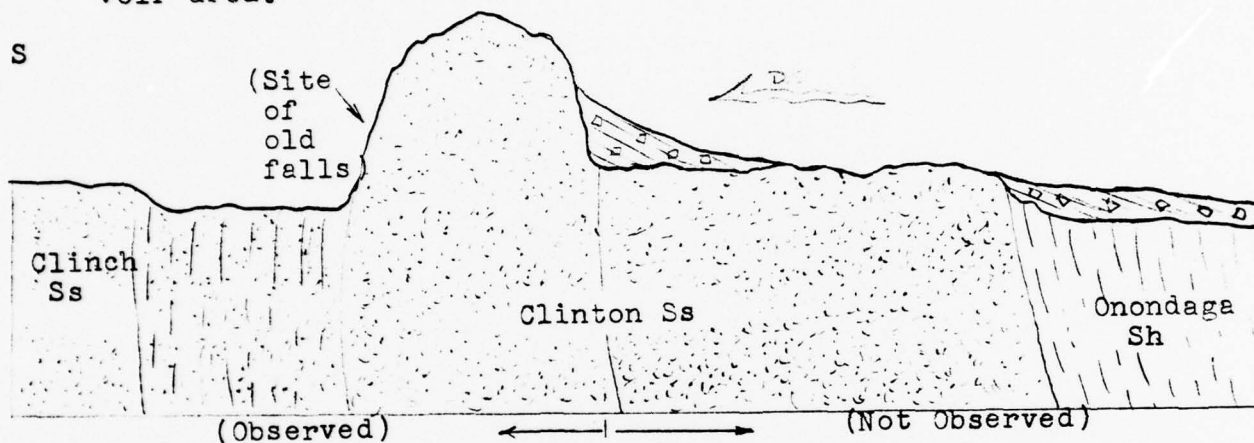
Figure 2. A generalized section taken normal to the dam alignment to illustrate the lithology of the dam site. (after Berkey, 1924)

Further foundation investigations at this time, other than observation of the springs on the right abutment, would seem to be unwarranted.

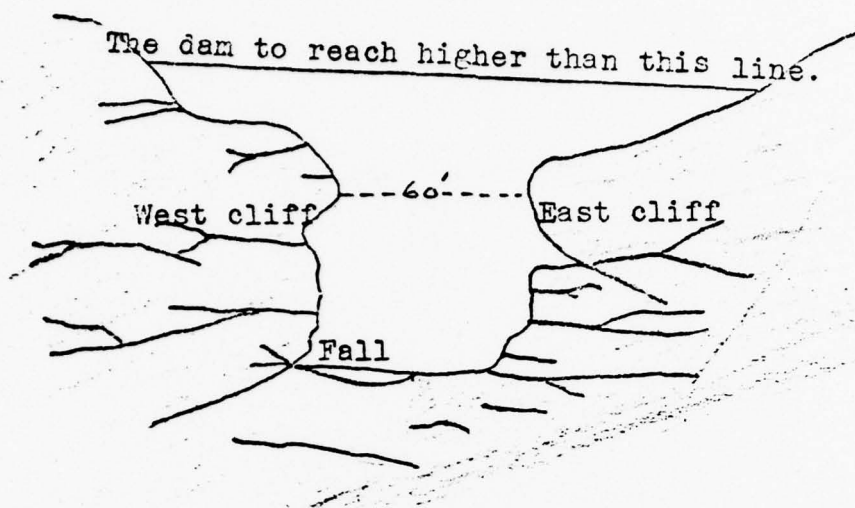
The notch cut through the main quartzite ridge by Carvins creek, as seen looking up stream. The irregular jointing of the rock ledges is shown, but the bedding structure runs from right to left and cannot be shown in this section.

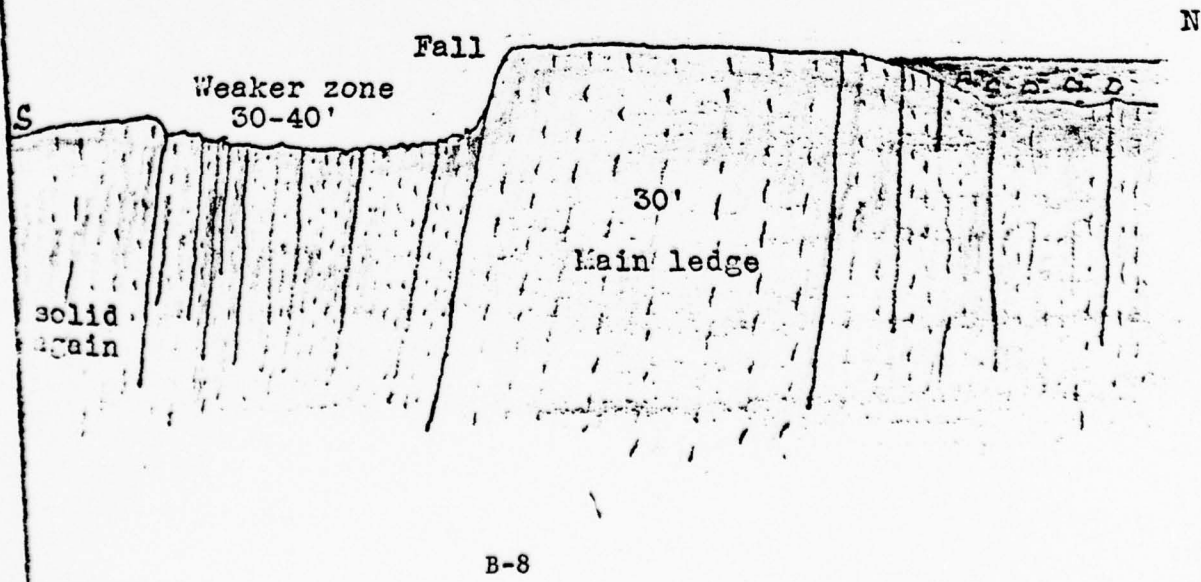
The ledges immediately behind (downstream from) the main quartzite ledge at the fall, for a distance of 30 or 40 feet, are thin bedded and show some slipping (bed faulting) between the beds so that there is somewhat more weakness in this zone of 30 or 40 feet than in most other portions of the quartzite formation. This is reflected in the local topography of the ledge, for it is marked by a depression taken advantage of by the fall and this is continued on both sides of the stream, as well as in the bottom. It is this ground that breaks away a little better or a letter faster than does the main quartzite ledge. The weaknesses that are in it, however, run practically parallel to the bedding and are essentially tight. A little circulation, doubtless, could take place along these weaknesses but they run parallel to the ridge instead of across it. Therefore, they are of little consequence in considering any possible loss of water through the ledge and dam.

Cross section designed especially to show the position of the zone of somewhat weaker rock below the main ledge.

This zone, however, is one that should not be disturbed unnecessarily. It should not be subjected to extraordinary demands such as might be placed on it if the spillway were allowed to discharge directly into this zone. Whatever is done in the matter of spillway arrangements should take this into account and the spillway should lead across this zone before discharging the waters. No other precaution is necessary.
